**EVALUATION STUDY ON  
PROTECTION OF HISTORICAL MONUMENTS AND  
DEVELOPMENT OF MUSEUMS TAKEN UP UNDER  
12TH FINANCE COMMISSION FUNDS**

**EXTERNAL  
EVALUATION  
REPORT  
No. 6 of 2014**

**STUDY CONDUCTED FOR  
KARNATAKA EVALUATION AUTHORITY  
AND  
DEPARTMENT OF ARCHAEOLOGY AND MUSEUMS,  
GOVERNMENT OF KARNATAKA**

**DECEMBER  
2014**

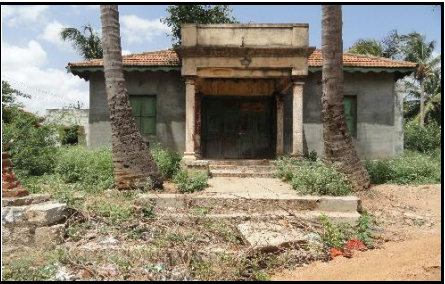
<p>Estimated Cost: 60.00 Lakhs</p> <p><b>GPS</b> 14°13'06".81N 76°23'57".79E</p>	<p>The compound is constructed around existing museum building on all four directions by digging foundation trench to the depth of 2'-4' by constructing size stone masonry with P. C.C and B.B.M wall all over. The cut size basement work resumed with 6-7 courses from the bottom (hidden) in cement mortar.</p> <p>Above this stone masonry dwarf wall BBM masonry wall raised with 14 courses of 9" thickness with BBM pillars at regular intervals @ 10' distance. Pointing work done without attending coping work, Iron grill frames were fixed on the compound wall on the main road side.</p> <p>In continuation of the work within the compound wall plastering work was executed in the main building on the wall surface in cement mortar, grilled windows &amp; doors fixed. Inner wall surfaces of the Museum were plastered.</p> <p>On the whole, work is as per the estimate provisions incomplete.</p>

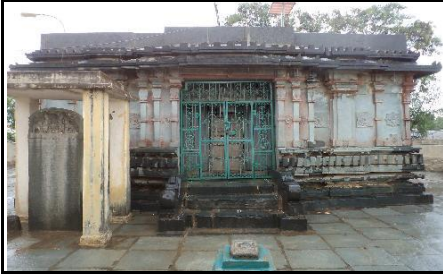
It is found that the original temple walls had slightly sunken with foundation by developing cracks/wide gaps with terrace material leaking heavily inside the monument making the entry difficult. The temple interior consists of Garbhagraha, Antarala with architectural door frames, and the Mantap with architectural pillars with ornamental main door frame. The Garbhagraha terrace roof with architectural stone Shikhara was in disturbed condition.

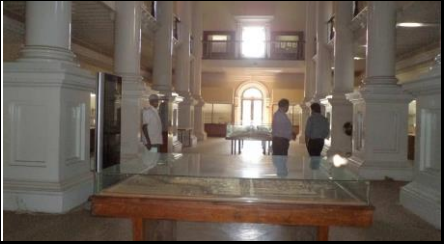
<p>8. Government Museum Bangalore</p> <p>Estimated Cost: 30.00 Lakhs</p>

<p><b><u>GPS</u></b> 12°58'27".56N 77°35'42".35E</p>	<p>Conservation and development works executed in and around the museum indicated that:</p> <p>Dismantling dead plaster developed with cracks, removing the same inside as per estimate,</p> <p>Work was executed long back and necessary photographs before and during conservation works not available. Only the following work was completed:</p> <ol style="list-style-type: none"> <li>i. It is found that the first floor, galleries, ceiling seen leaking in five spots on the wall and ceiling joints. Plaster of paris works executed inside outside seen and satisfied.</li> <li>ii. Removing white wash, colouring &amp; plastering work executed. Repairs to Doors and windows carried out. Flooring work executed with joints neatly finished. Pointing to outer walls of buildings pointed as per estimate.</li> <li>iii. Overall museum works were found to have been executed as per estimate provisions and were found satisfactory.</li> </ol>

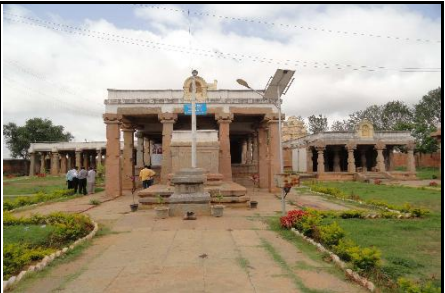
<p>9. Conservation of Sri Someshwara temple complex at Magadi, Magadi Taluk, Bangalore Rural District</p>

<p>It is found that the main temple is located within the center of the tall dressed stone granite stone prakara wall with massive granite stone chambers on both the sides with tall towers built in BBM with stucco figures all over with flight of steps and balustrades in the front.</p> <p>Within the prakara structures found are Devi Bramarambika temple, Sri Satyanarayan temple, Kalyanotsava Mantap, Nyaya Mantap and Kempegouda's Hazara.</p> <p>The temple consists of Garbhagraha, Antarala and Mantap with two entrances adorned with door frames and architectural pillared Mantap in the front. The Antarala has got two standing Dwarapalas, the front pillared Mantap has two beautiful lotus with petals and bud carved in the center of the ceiling, while the</p>

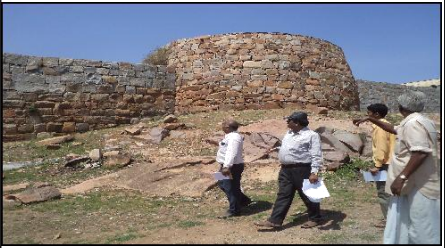
<p>14. Conservation of Srimanthagada fort at Devihal Shirhatti Taluk Gadag District.</p>

<p>The fortification wall is constructed on a hill top with the bastions built in massive granite stones to a height of about 6.00 mtrs on all corners with the gates and sluices provided in between on a natural granite bed rock with coping on the top of the wall. This fortification wall is constructed with two faces with a width of about 3.00 mtrs. The core in between the two faces is filled with UCR stones course with murum. The dilapidated massive granite stone masonry wall standing with its missing original members were, numbered course by course and</p>

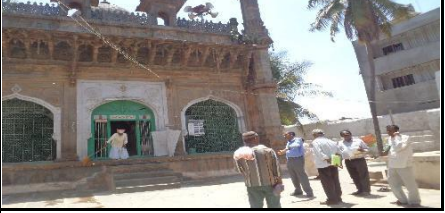
<p>Built with number of carvings all over the front elevation and chejja around with 4 tall Minars standing on raised platform with ornate Adhistana.</p>
<p><b>History of the Monument:</b></p> <p>Lakshmeshwar is one of the ancient historical place in Gadag District. This town is having Hindu, Jain and Islamic monuments. Kaliya Masjid is one of the historical ancient living masjeed in Karnataka. This structure is constructed by good quality black stone and well trained sculptors.</p> <p>Estimated Cost: 7.00 Lakhs</p> <p><b>GPS</b>  14°48'26".55N  76°45'10".77E</p>	<p>The items of works were executed as per the estimate by replacing the missing members by carving and dressing as per the original and are in accordance with the archaeological work codes, principles and guidelines are found satisfactory without damaging any architectural part of the monument.</p>

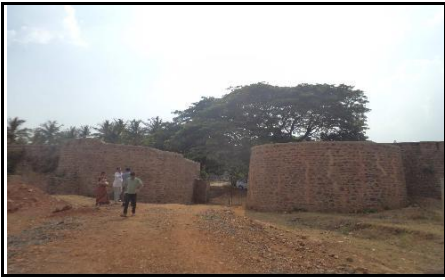
<p>21. Conservation of Kittur Fort at Kittur Bailhongal Taluk, Belgaum District.</p>	<p>The two bastions with both sides of the East main entrance to the fort are in fully disturbed condition and growth of vegetation has partly collapsed. Both the collapsed structures are built in U.C.R stones to the height of the existing fort with coping and pointing, center core of the bastions filled with earth.</p>

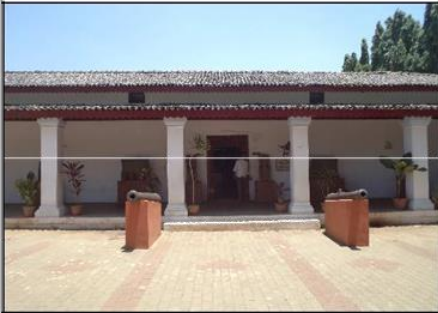
On a study of the work carried out Museum/Monument using the photo documentation of conservation works, it was found that the monument/museum building was in highly disturbed condition with rotten wooden rafter carved with the covering of local terracotta tiles etc. The corridor around the building is standing only with pillars, without roofing etc.

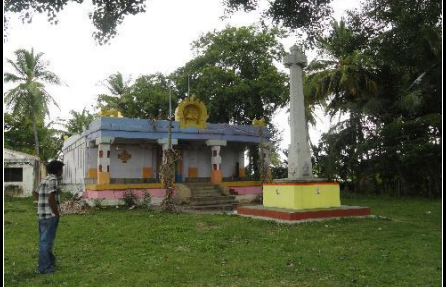
<p>While studying the works it is found that the monument was in highly dilapidated condition with modern size stone masonry and brick masonry walls on the eastern side. The terrace roofing was broken with dead material; parapet and other architectural members were covered under heavy earth deposit hiding the plinth.</p>
<p><b>History of the Monument:</b></p> <p>Yoga Narasimha Swamy Temple situated in Arakere Village of Srirangapana Taluk, Mandya District is an ancient Temple. The Temple is constructed by Granite stone seems to be in Vijaya Nagar Style.</p>	<p>The numbers marked on each and every stone in red ochre colour course by course shows that before taking up conservation work for identification of the respective members, numbering procedure was followed. It shows that the entire temple was dismantled top to bottom, except Garbhagraha and Antarala portion. Further, the sunken foundation was removed with all the old material and restored by providing cement concrete bed and filled with U.C.R stones with a coping over it.</p>

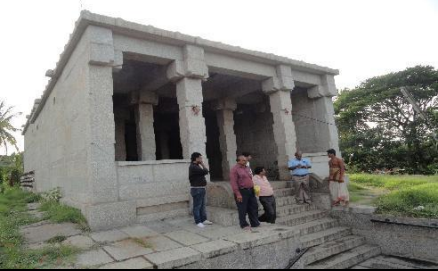
<p>While taking rounds around and interior of the monument, it is found that the temple was constructed in massive granite architectural members in Dravidian style consisting Garbhagraha, Antarala with ornate door frames and Lalatbimba with highly ornate Lotus carving on the ceiling center, the interior of Garbhagraha, Antarala, Bhatti, Ceiling and flooring with the original members are safe, while on exterior of the temple only Adhistana with the architectural mouldings are available. Rest of the Bhatti and superstructure are totally missing.</p>
<p><b>History of the Monument:</b></p> <p>Maddur is situated on the Mysore – Bangalore Highway about 65 km from Mysore and 80 km from Bangalore.</p> <p>Protected Monument and is a living temple situated in heart of the Maddur Town. The Varadaraja temple is infact only a small part consisting of the Garbhagriha and Sukanasi. The</p>	<p>In case of exterior plinth and the interior Garbhagraha and Antarala each and every stone member was marked with numbers in red ocher color course by course till the bottom both on interior and exterior veneerings are existing. The work</p>

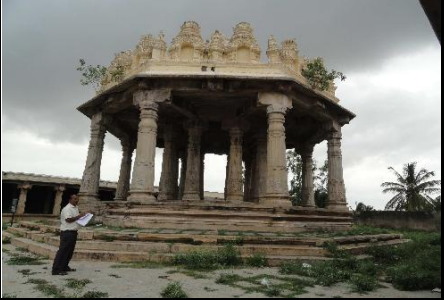
<p>The works were carried out by the contractor in accordance with the estimate provisions. Before beginning of conservation works, the thickly grown jungle, bushes around the monument was removed and cleared. Secondly the disintegrated WPC including Gopura on the top of Mantap, was dismantled carefully without causing any damage to the monument restored with the lime concrete (Surkhi) with lime plaster coating as per original (WPC). Granite stone flooring with dressed stone of rectangular/square shape was provided all over the inner surface of the Mantap, while Granite stone pavement around the monument was provided all over the surrounding of the monument with pointing and Stone joints in cement mortar in thin lines including inner floor of the Mantap.</p>
