**EVALUATION STUDY ON  
PROTECTION OF HISTORICAL MONUMENTS AND  
DEVELOPMENT OF MUSEUMS TAKEN UP UNDER  
12TH FINANCE COMMISSION FUNDS**

**EXTERNAL  
EVALUATION  
REPORT  
No. 6 of 2014**

**STUDY CONDUCTED FOR  
KARNATAKA EVALUATION AUTHORITY  
AND  
DEPARTMENT OF ARCHAEOLOGY AND MUSEUMS,  
GOVERNMENT OF KARNATAKA**

**DECEMBER  
2014**

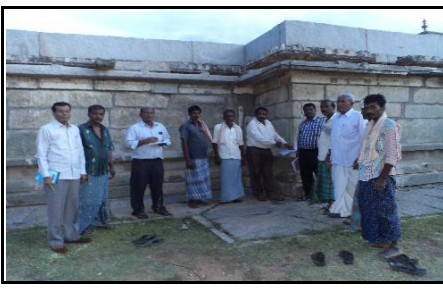
4. Conservation of Sri Bala Lingeswara temple at Vignasanthe Tiptur Taluk, Tumkur District

It is found that the original temple walls had slightly sunken with foundation by developing cracks/wide gaps with terrace material leaking heavily inside the monument making the entry difficult. The temple interior consists of Garbhagraha, Antarala with architectural door frames, and the Mantap with architectural pillars with ornamental main door frame. The Garbhagraha terrace roof with architectural stone Shikhara was in disturbed condition.

New members replaced missing members by carving & finishing.

<p>Estimated Cost: 30.00 Lakhs</p> <p><b><u>GPS</u></b> 13°08'58".16N 76°32'25".77E</p>	<p>The work executed was found to be in accordance with the archaeological works code, principles and guidelines without causing any harm/de-facing &amp; deviating as per original alignment etc and work completed.</p>
<p>5. Conservation of Sri Rameswara temple at Chittur, Sorabha Taluk, Shimoga District.</p>

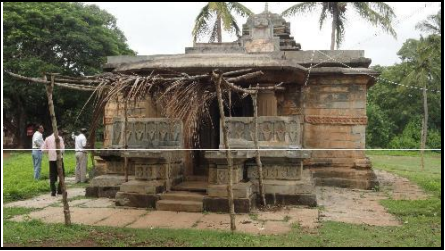
<p><b>History of the Monument:</b></p> <p>Chittur Village of Soraba Taluk is at about 60 km from Shimoga. Sri. Ramashwara Temple is situated at entrance of the village.</p> <p>The temple consists of a Garbhagriha, Sukhanasi, Navaranga and a small porch. The Sukhanasi Doorway has perforated panels on either side of the opening. There are 8 rings in the Navaranga three of which are empty. The pillars of the porch are sixteen-sided while those in the Navaranga</p>	<p>The monument is situated at an elevated area on a stone platform constructed in schist stones consists an ornate Garbhagraha with door frame Lalatbimba etc Antarala with ornate door frame &amp; beautiful ornate pillared Mantap and floral carvings etc. The ceiling of the Mantap consists of a beautiful lotus with a bud on the exterior entire temple from Adhistana to Shikhara with full of rich architectural carvings of Hoysala styles with open Pradakshinapath enclosed by modern compound wall with large open space in the front provided with M S Gate.</p> <p>The overall temple structure is in good condition except its left side Bhatti wall, Garbhagraha &amp; Antarala exterior corner slightly sunken.</p> <p>It is found that the temple built up with Schist stones with architectural members standing on 'Kumuda' moulding Adhistana with Bhatti and super structure of Vimana and interior with Garbhagraha with ornamental door jambs and Lalatbimba. While the Mantap has ornate pillars carved with round cushions with base and capitals. Mantap has 8 beautifully carved niches with cult deities and the center ceiling with beautiful 'Lotus' carvings.</p> <p>It is noticed that each and every stone was marked with numbers course by course in order, up to the bottom before taking up the conservation work as per the archaeological conservation procedure.</p> <p>While removing the broken dead and leaking weathering course with the parapet, was followed by dismantling according to the</p>

<p>are of the usual round shape. The Goupra is an ordinary one in stone with no carryings or ornamentation.</p> <p>Estimated Cost: 50.00 Lakhs</p> <p><b><u>GPS</u></b>  14°18'41".99N  75°14'45".97E</p>	<p>numbers from top to bottom -both interior and exterior- and along with pillared Mantap ceiling, flooring and Mukhamanatap except Garbhagraha interior including the sunken foundation.</p> <p>The water tightening work taken up shows the old dead original roofing was removed &amp; re-laid with the new and old stones on the same pattern with madras terrace &amp; Yelahanka tiles before taking up above terrace work.</p> <p>Parapet stone members missing restored as per original with dressing &amp; finishing in missing places.</p> <p>New stone water dropswere re-laid &amp; cut in new stones &amp; finished as per original.</p> <p>New compound wall with big Iron Gate is provided with 5' height &amp; with double face.</p> <p>BBM with the brick pillars in cement mortars with regular intervals 10' each and plastering work was done &amp; completed.</p>

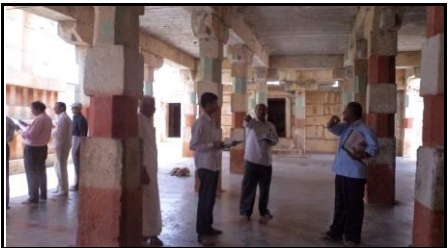
<p><b>History of the Monument:</b></p> <p>Virupakshapura is from Mulabagalu situated adjacent to the National Highway 4.</p> <p>Eshwara temple is very big in size and is situated at the end of the village Virupakshapura. The Virupaksh temple in Virupakshapura village is a very large temple built during the reign of the Vijaynagar king Devaray – II. The temple is of Dravidian type with there</p>	<p>The temple situated on an elevated area within the tall prakara wall at the end of the village, facing East built in granite stone architectural members of Vijaynagar style and consists of Garbhagraha and Antarala with architectural carvings of door frames and Lalatbimba etc with a front architectural pillared Mantap along with sub shrines in the front and rear.</p> <p>On the north eastern corner of the main gate a large Pushkarani built in Granite stones and a ruined structure is also seen. The main entrance to the temple with large ornamental door frame and architectural pillared chambers on both the sides of the entrance along with tall monolithic door jambs are carved with large beautiful figures of standing Ganga and Yamuna. Exterior of the entrance has two open platforms along with staircase and balustrades.</p> <p><u>MAIN TEMPLE</u></p> <p>The entire temple complex was found in highly deteriorated condition with the collapsed walls/out of plumb accumulation of earth deposit and wild vegetation. The terrace was disintegrated with dead material leaking heavily known from the interior ceilings. The main temple and sub shrines were found with lot of missing members on Bhatti, Kanta, Hara, Kapota while remaining portions had developed cracks and found out of plumb, needing immediate restoration work.</p> <p>It is noticed that numbering of each and every stone member of the temples and shrines inside the complex in red ocher color indicating that the procedure of archaeological conservation of</p>

<p>mahadvar of which the first was gigantic structure.</p> <p>Estimated Cost: 60.00 Lakhs</p> <p><b><u>GPS</u></b>  13°08'36".38N  78°22'00".50E</p>	<p>monuments was followed before taking up the work. Next work began with dismantling of terrace, ceiling, Bhatti and some portions of Adhistana with massive granite architectural members. Except Garbhagraha and interiors of the main shrine running numbers course by course up to the bottom basement have been followed.</p> <p>While executing other conservation measures, like the leaking roof with dead weather proof course was removed along with the ceiling. Other architectural members of Parapet, Kapota, Hara, Kanta and Bhatti exteriors around the temple were followed course by course with respective numbers up to Adhistana only.</p> <p>While restoring the Bhatti, Kanta, Hara and Kapota respective numbers were followed and reset as per original by including maintenance of original alignment course by course by filling the wall gap with BBM in lime surkhi up to the Kanta level along with new Bhatti members, replacing new members in place of missing original members by carving and dressing as per original. Similarly Kanta, Hara and Kapota were restored with the original members along with newly finished architectural members in place of missing original members all around the temple.</p> <p>The Garbhagraha and Antarala interior original ceilings and veneerings were maintained. The front pillared Mantap ceiling, side walls, flooring, pillars were dismantled and restored as per original by resetting out of plumb and sunken flooring and disturbed ceiling etc. Pointing work all over the stone joints was executed in cement mortar including tightening by WPC and madras terrace roofing.</p> <p>The overall conservation work executed was found to be in accordance with the archeological works code, principles and guidelines, without causing any damage/harm/mutilation/defacing the original members and is most satisfactory.</p>

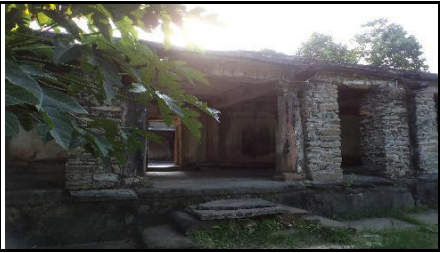
<p>19. Conservation of Sri Gaddigemath and Mahantimath at Sonda Sirsi Taluk, North Kenara District</p>

<p><b>History of the Monument:</b></p> <p>The Mahantimat in Sonda Sirsi (Tq) Uttar Kannada District. Is 16<sup>th</sup> Century of Vijaynagar Period During this period 6</p>	<ol style="list-style-type: none"> <li>1. The work has not been completed. However the partial work was executed without harming the structure / architectural member almost in accordance with the archaeological work codes, principles and guidelines.</li> <li>2. This work has not been taken up due to dispute between two family members.</li> </ol>

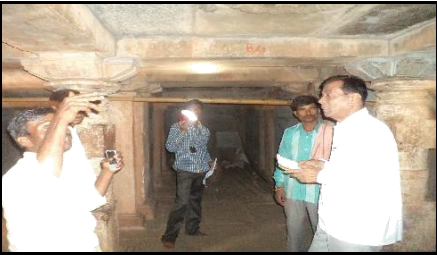
<p><b>History of the Monument:</b></p> <p>Devarsigehalli is 8 km from N.H 4 near M.K. Hubli, village have app 6000 population. Temple is in the middle of village. Temple mainly trikutachala two shivlinga and one surya gaarbagrahs. One Vikramaditya 6<sup>th</sup> inscription in the antharala pillar of surya temple, saptamatrika sculpture in entrence and hero stone in</p>	<p>The temple / monument consisting of two temples namely Suryanarayana and Eshwar temples, is situated in the middle of the village on a, raised rectangular large platform built with size stone masonry (S.S.M) was fully destroyed highly disturbed and in damaged condition. Both of them originally were built in schist stone, probably Suryanarayana temple was restored subsequently with Laterite stone members covering on the exterior of the temple. But the inner side all the original architectural members were found in good condition.</p> <p><b><u>ESHWAR TEMPLE</u></b></p> <p>The Eshwar temple consists of 3 Garbhagrahas with a rectangular shape common hall or Sabha Mantap with 8 pillared Mantap with Shivalinga in the 1<sup>st</sup> Garbhagraha.</p> <p>Number marks were found on eachand every stone of the monument both inside and outside when compared with photographs taken before, during and after conservation. It is evident that the temple was dismantled from top to bottom and restored by replacing new architectural/plain dressed members as per original. The inner part of the temple was restored almost with the original members whereas the exterior part was restored with new stones. The core between the two faces of the wall was packed with BBM in lime surkhi. The original pillars and beams were arranged in their original position and covered with</p>

<p>back side of surya gharbhagrah.</p> <p>Estimated Cost: 20.00 Lakhs</p> <p><b><u>GPS</u></b></p> <p>15°39'57".60N</p> <p>74°42'41.28E</p>	<p>original ceiling slabs by replacing new ones wherever necessary. The Kanta, Hara and Kapota portions were fully restored with newly carved architectural/plane dressed stone members. The parapet all-around the temple roofing was restored with new stones as per original by dressing and finishing along with water drops.</p> <p>Thin line pointing work has been done inside and outside the temple stone member joints in cement mortar. The WPC work was done with madras terrace roofing, plain cement concrete and Yelahanka tiles Roofing.</p> <p><b><u>SURYANARAYAN TEMPLE</u></b></p> <p>The conservation work of the temple was done on the same lines as in the case of Eshwar temple and restored as per original. The temple was originally built in Schist massive architectural stone members and subsequently restored with Laterite stones on the exterior of the temple. Whereas, the original architectural members with door frame and Lalatmbimba beautifully carved show the originality of the temple.</p> <p>The same structure was dismantled along with the foundation and restored with the same members as per original by following the archaeological principles and guidelines as done in the case of other temple examples since original members were missing since long back and were restored earlier before taking up the conservation work. Hence the same pattern of Laterite stone replacement seems to have been followed. As there were some weak and broken architectural members on the rear side of the door jambs and front they were replaced with new members by dressing supported the ceiling.</p> <p>Finally flooring was restored by replacing with new members. While terrace was restored with madras terrace</p>

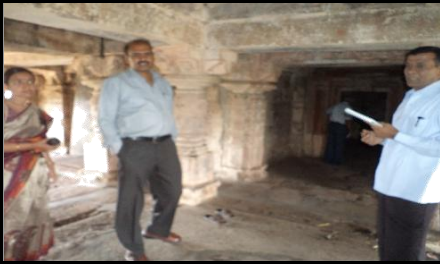
23. Conservation of Sri Eshwara temple complex Hebbal Basavana Bagevadi Taluk, Bijapur District

<p>Before, beginning of main temple restoration work, the required strong foundation was laid with the bed concrete and rubble stone masonry and levelling. While beginning with resetting of basement by following the original alignment further following the same alignment and respective numbers of Adhistana were completed. In continuation of the Bhatti up to terrace level work completed with double veenering and packing the gap in between with BBM and cement mortar.</p> <p>The inner and Antarala portions along with Mantapa pillars and beams were restored to the original position and covered with the ceiling slabs as per original by replacing all the missing members by carving and dressing as per original.</p> <p>Further, chejja, parapet, were restored with terrace roofing in WPC and madras terrace roof with rain water drops as per original style.</p> <p>The newly carved/plain stone architectural members replacing old ones were: Lalatmbimba above the door frame at the entrance. Beams restored as per original-Capitals -Capital disk- Pillars-Pillar bases-Door Jam Veneering.</p> <p>Overall conservation work carried out was found to be in accordance with the archaeological work codes, principles and guidelines the work without harming/damaging/defacing the monument found satisfactory.</p>

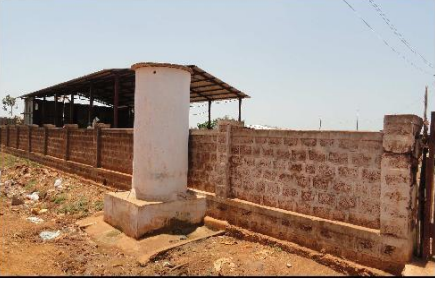
<p>Estimated Cost: 5.00 Lakhs</p> <p><b><u>GPS</u></b>  15°00'26".00N  75°07'41".48E</p>	<p>between at regular intervals in Laterite stones with cement mortar along with a concrete coping and pointing on both sides of the wall throughout the length as per the estimate with M S Gate with R.C.C pillars. Teak wood door provided.</p> <p>The flush pointing and thin pointing work done inside and outside the throughout the length of the compound wall in cement mortar.</p>
<p>25. Conservation of Parasagada Fort and Kadusiddeshwara temple Soundatti Belgaum District.</p>

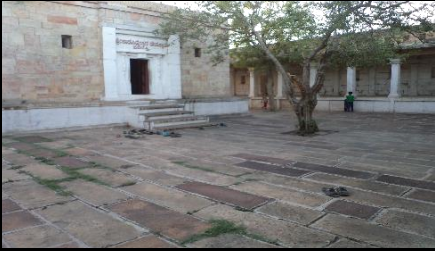
<p><b>History of the Monument:</b></p> <p>Parasagada Fort is one of the intact forts in Belgaum District. Fort Temple was built in the 16<sup>th</sup> Century. This is living temple so many devotees visit the temple daily.</p> <p>Estimated Cost: 6.00 Lakhs</p>	<p>The temple/monument is situated on the top of an elevated/hillock with a tall fort with round lofty bastions with Merlons on the top all over the fort built in quartzite stones with large main gate and arch in the front provided with flight of steps. In the center of the fort, the main temple is located on a platform in square shape with Pyramidal Shikhara and one shala and Pradakshinapath around. Around the Pradakshinapath a cloistered Mantapa facing temple with Monolithic pillars on lofty dwarf plat-form with chejja and parapet at the top built in Quartzite stones. Temple inside consists of Garbhagruha, Antarala and Mantap with entrance on three side, while main entrance falls on the east with beautiful large door frame with flight of steps in the front.</p> <p>While observing the conservation works carried out it is found that certain portions of fortification wall in and around partially collapsed, have been taken up for resetting and strengthening of the fortification.</p> <p>The numbers marked on each and every stone course by course up to the bottom in red ocher color show that before taking up conservation work for identification of the exact position of each</p>

<p><b><u>GPS</u></b> 15°45'10".08N 74°56'30".67E</p>	<p>and every stone member numbering has been made as per the archeological conservation procedure.</p> <p>During the conservation as per estimate provisions outer face of the fortification the weak and sunken foundation with partially collapsed walls at the front places were cleared by removing the dead and useless material from the foundation and restored with the new material. In continuation of the work, the bottom course restored as per original with the new material in cement mortar as per alignment by following the respective numbers course by course. Entire portion of the fortifications was restored in the same procedure and completed as per the estimate provisions. The fortification coping was provided in cement concrete following original work completed.</p> <p>The conservation work executed is in accordance with archaeological works code, principles and guidelines without harming/damaging/defacing the monument are appreciated. But, instead of using abundant new stone members the efforts should have been made for tracing the original members as there is no chance to miss them from the site because they might have been buried in the surrounding itself.</p> <p>The historical facts say that the monument built in recent late period, could have collapsed after a lengthy rule. Hence after the fall of kings or defeat of or taken over by the successors could have been neglected and detonation might have taken place.</p>

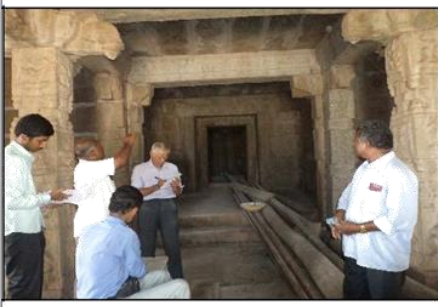
The temple consists of Garbhagruha, Antarala with architectural door frames with Lalatbimba and Mantap with architectural pillars and with three main entrances on the North, South and East in highly disturbed condition missing with some architectural members of plinth, Bhatti, Hara, Kapota, Parapet and terrace WPC material. Temple plinth was found sunken in the foundation with some missing architectural members.

While observing, the conservation works it is observed that the numbers marked on each and every stone in red ocher colour course by course shows that before taking up conservation work, for identification of the respective members the procedure followed, during the execution of conservation work, the entire temple was dismantled top to bottom except Garbhagraha. Further, the sunken foundation was removed with all the old material and restored by providing cement concrete bed and filled with U.C.R stones with a coping over it.

The overall conservation work executed is in accordance with the archaeological work codes, principles and guidelines without causing any damage / harm to the architectural members without any deviation in following the alignment was found to be very satisfactory. However, addition of new architectural members introduced by carving / finishing as per original is against the archeological principles. Instead of carvings, available defaced/mutilated plain members should have been used by

<p>mending in order to restore and strengthen its original grandeur. Since only few members were introduced as per original, this can be exempted from the application of works code as negligible.</p> <p>The overall conservation work executed in accordance with the archaeological work codes, principles and guidelines without causing any damage/harm to the architectural members without any deviation in following the alignment was found very satisfactory.</p> <p>However, addition of new architectural members introduced by carving/finishing as per original against the archeological principles. Instead of carvings the plain members could have been used by mending in order to restore and strengthen to its original grandeur. Since only few members introduced as per original can be exempted from the application of works code as negligible.</p>
<p>28. Green Law Gallery at Hampi Hospet Taluk Bellary District.</p>

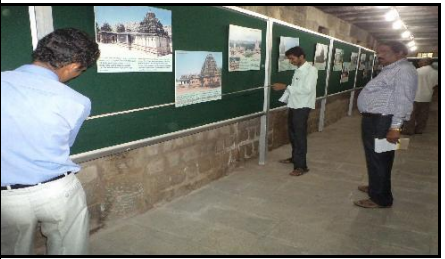
<p><b>History of the Monument:</b></p> <p>The Green law Photo Exhibition Gallery is in Hampi in a mantapa Hospet Taluk Bellary District. It is maintained by the Department. The green</p>	<p>The following works were executed, (physically verified) in accordance with the estimate.</p> <p>Unpolished stone slabs supplied and work executed.</p> <p>ventilator frames fixed, Aluminium frame with both side display boards with background cloth supplied,</p> <p>Electrical materials supplied and execution including pipe line wiring with switch board, switch points with fixtures executed, main switch board supplied and fixed. Exhaust fans supplied and fixed, pedestal fans supplied.</p> <p>Over all, the work in accordance with the estimate provisions and bills tallied and was found satisfactory. Works executed was found and physically verified in accordance with the estimate.</p>

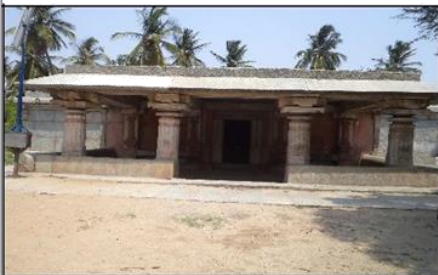
The ceiling and flooring, are finished with dressed granite rectangular slabs. The original broken and dead terrace provided with WPC leaking heavily was found in highly dilapidated condition.

While verifying the conservation works carried out, it is found that marks were numbered on each and every stone member both on interior and exterior showing the procedure of taking up conservation work before dismantling any part of the monument. Further in dismantling of monument architectural members begins with removal of dead weathering course material as per the archaeological conservation norms. Accordingly the whole temple structure top to bottom was dismantled except Garbhagraha. The original foundation trench sunken here and there was removed with the original material.

While executing the main conservation work of the temple the foundation trench was strengthened by constructing U.C.R stone masonry as per estimate. The resetting of main structure was followed as per numbers marked on each and every stone member up to the Kanta portion. In continuation, two top courses of Hara and Kapota were restored as per original. The entire structural work was completed mainly with original stones in the interior and partly with new stones on the exterior. The roofing and the flooring were finished as per original by using original stone members along with new stone members and dressed and finished as per original in place of missing. Thus the front pillared Navaranga was restored with the original members.

The front chejja and parapet around the temple with water drops completely were replaced with new stone members by carving and dressing as per original. The temple terrace water tightening was done with WPC, PCC and cement plaster.

<p>Finally, the pointing work was done all over the interior and exterior of the monument in thin line with the cement mortar.</p> <p>Newly replaced architectural/plain dressed members replaced as per original were: 69 members, New chejja , ceiling stones, northern side stone member, ‘Mulegamba’ (Corner pil lars), ceiling slab,pillar capital, inner veneering replaced and reset, threshold plane stone member,Granite stone pavement all around the temple laid with new members.</p> <p>The overall conservation work executed in accordance with the archaeological work codes, principles and guidelines without causing any damage/harm to the architectural members and deviation of alignment. Though they are broken and mutilated by mending or giving and hidden supports were not taken care. However, addition of new architectural members by carving /finishing as per original are highly objectionable as lot of members were used giving a new look to the monument as if it is modern temple. However, under these difficult circumstances of restoration work without providing new members in place of missing work cannot be completed and monument cannot be restored.</p> <p>In view of the need for protection of the monument and heritage under unavoidable circumstances the work executed may be treated as worth and considered a good contribution done to the archeological monuments. Hence the above work executed by new members in place of missing may be taken in the spirit of protection of heritage and relaxed from the any objectionable point.</p>

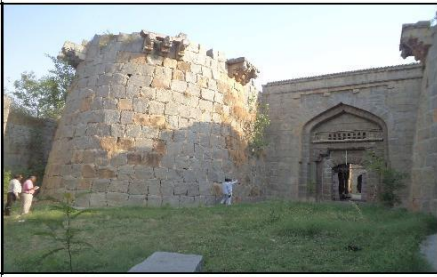
<p>31. Government Museum Navarang Dharwaz Raichur.</p>	<p>The Museum/Monument is situated on the Northern gate of the fortification in the heart of the town facing East.</p> <p>On comparison and verification of conservation works, it was found that,</p>

- b. The fortification wall and the main gate on the northern side were in highly disturbed condition with missing stone members etc. Each stone member was marked with numbers course by course up to the bottom. The present situation of the fortification wall gives an impressive look without many gaps in the stone joints in perfect alignment top to bottom. Pointing and coping existing is evident that the work carried out in accordance with the estimate provision.

- d. Huge rectangular unfinished new stone blocks measuring about 2.5mts length were found lying in museum premises.
- e. Chain link G I Mesh about 2' height with angle supports fixed on the roof edges of south gate and it is open to sky.

<p>was executed in round shape, which should have not been done as it spoils the architectural member, instead, a thin wire mesh covering would have been sufficient.</p> <p>It seems that while executing the conservation works, the full shape has been restored to the monument/museum as per original style in accordance with the estimate provisions and archaeological works' code, principles and guidelines etc without causing any harm / defacing / mutilation/deviation in the main structure.</p> <p>However, the work executed in accordance with the estimate provisions and bills tallied was found satisfactory.</p>
<p>32. Conservation of Venkateshwara temple complex Gabbur Devadurga Taluk Raichur District.</p>	<p>The temple/monument is situated on the South western side of Kalayani facing North within the village. The main temple of Sri Venkateswar is built in massive Granite architectural stone members consisting Garbhagruha dedicated to Lord Vishnu and western side a shrine dedicated to Lord Shiva with ornate door frame and Shikhara style of carvings below the ceiling, Antarala with rectangular Jalandar windows carved with floral designs, Navaranga with ornate pillars standing on architectural base with cushions and capital stones at the top. The temple ceiling is fully carved with beautiful Lotus flowers with buds on four sides. Mantap center ceiling carved with bigger size Lotus with petals and buds are more ornate. Main entrance door frame with beautiful architectural carvings and side Bhatti is provided with perforated rectangular Jalandar windows with standing 'Dwarapalas' and floral designs. The plinth of the temple is carved with the same floral architectural designs around on the exterior while the Bhatti with 'Devakostas' and 'Jalandaras' around the Mantap.</p> <p>The Antarala and Garbhagraha portion are built with solid massive dressed stone with Devakostas. The Adhistana is more</p>

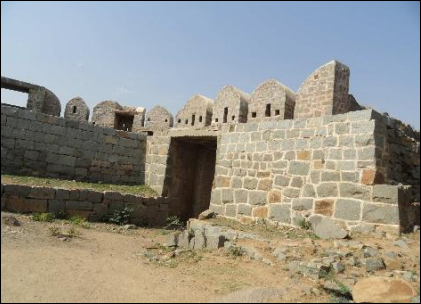
<p>Estimated Cost: 20.00 Lakhs</p> <p><b><u>GPS</u></b> 16°00'49".27N 76°26'05".31E</p>	<p>The Fort/Monument is situated on the way to Ilakal in Mudgal village by the side of hills facing North with large entrance gate built up in massive Granite stone masonry, tall and lofty walls running on top of hills with number of entrances and murlons.</p> <p>The conservation works carried out as per estimate provisions after conservation included:</p> <p>The monument walls had collapsed/developed cracks out of the plumb etc causing further deterioration to rest of the fortification walls and chances of missing original numbers.</p> <p>Under the circumstances stopping further detonation and protection of the monument works were taken up and restored as per original by using the same old material along with the new stone members and a few architectural carvings without causing any damage/defacing/mutilation/deviation as per archaeological norms and principles such as:</p>

<ul style="list-style-type: none"><li>a. Newly carved fortification wall stone /plain dressed members were replaced as per original</li><li>b. Earthwork excavation, removal of vegetation done.</li><li>c. The front main gate right side collapsed partially restored with available stone members along with new stones to an extent of about 2.00mts height, 1.2mts width and 80.00 mts length as per original shape and style.</li><li>d. Fallen original Merlons collected and restored as per original.</li><li>e. In respect of Inner Gate (II) a collapsed wall portion missing with original stones was restored with new stones as per the original along with the parapet and coping concrete including attending – WPC</li><li>f. A dilapidated fortification wall connecting two entrances was restored with available original stones along with new stones in place of missing ones as per the original to the original height. The core between the two faces of the wall was filled with murum with granite boulders.</li><li>g. Pointing work done in cement mortar in thin line all over the area</li><li>h. Emergency gate in dilapidated condition was dismantled and restored with original stone material by adding new stones including finishing as per original and core between the two faces of the wall filled with murum and granite boulders.</li><li>i. The small entrances structure standing above the fort wall near the entrance facing the road built in lofty granite walls with an entrance passage which was in dilapidated condition was dismantled and restored as per original with the original material along with new</li></ul>

<p>dressed member.</p> <p>j. A dilapidated fort wall in front of Gate III entrance was restored to the original to the same height by using original and new stones by trimming and dressing wherever necessary.</p> <p>k. Another fort wall in front of Gate IV, in fully dilapidated condition and lot of stones missing was fully dismantled and restored with new stones along with old ones as per originality. No coping and pointing work done.</p> <p>l. At fourth entrance gate front face out of plumb removed and replaced with new material in missing places, while damaged brick masonry work on arch portion was restored in BBM and lime mortar as per original mouldings, geometrical and floral motifs.</p> <p>Over all work done was in accordance with archaeological work codes, principles and guidelines without causing any damage to the monument except using new stone in order to complete the work and maintain in original shape and good strength. The timely work done has really protected the monument from further destruction.</p> <p>The work executed deserves the appreciation.</p>

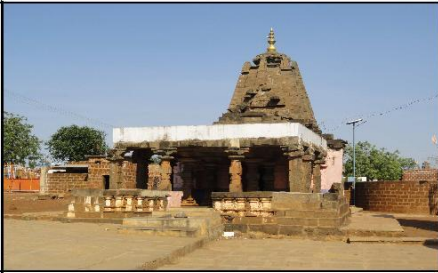
<p>34. Conservation of Sri Umamaheshwara temple at Umapur, Bidar District</p>	<p>The temple/monument, is constructed on a low height platform with Adhistana of massive rectangular stones with the carvings of Kumuda above this the plain Bhatti constructed the superstructure Vimana in Nagar style with a Kalasa in the center over the Amalakha is situated close to the village. At the bottom in the front carvings dancing and musician ladies figures are seen. The whole structure has been constructed in black Deccan trap. The temple inside consist Garbhagruha, Antarala and Navaranga with Kakkashasana in the front facing East, while</p>

The monument was found in developed with cracks on Vimana Gopura, veneering and in Adhistana. Some beams broken, Eve beams, Chejja and ceiling members missing. The heavily leaking madras terrace roofing broken with dead material due to lengthy period of sustaining.

It is found that the tall structure each and every stone member was numbered course by course in white color top to bottom from Vimana. It shows that before taking up the conservation works as per procedure of conservation method was followed. The dead terrace and Vimana members were dismantled by following the respective numbers course by course up to Bhatti and entrance porches. The ceiling and the front Mantapa was dismantled including portions of Garbhagruha, Antarala. Restoration work was taken up by resetting of the respective numbers in their original positions course by course up to Vimana by covering the ceiling over the pillared Mantapa and providing WPC roofing over the terrace. The missing Sukanasi retained was in its original position. The Mukhamantapa Kakkashasana disturbed with missing members was restored as per original. In the whole structure missing architectural members were replaced by carving/finishing as per original including providing stone pavement around.

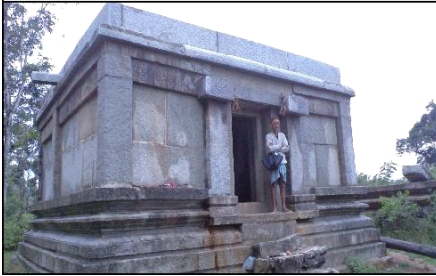
38. Conservation of Sri Keshva and Eshwara temple group at Angadi, Mudigere Taluk Chikamagalur District.

<p>massive granite members.</p> <p>The parapet around the Mantap was restored with new granite massive stone members with plain dressing, by providing rain water drops in between. Incomplete weather proof course was provided, resulting in heavy leakage and causing lot of damage to the monument.</p> <p>The overall conservation work executed with introduction of new granite massive stone members to the entire exterior and interior of Mantap with new pillars, bases and capitals along with ceiling and flooring, entrance door frame work probably executed on the presumption of original existing Mantap, is highly objectionable since it is not in accordance with the archeological work code, principles and guidelines.</p> <p>The original architectural members either broken/mutilated should have been mended and restored as some of them were seen scattered in the front of the temple.</p> <p>The new Mantapa creation on the presumption should have been avoided, while framing the estimate itself. On what basis the Mantapa restored is a question mark (?).</p>

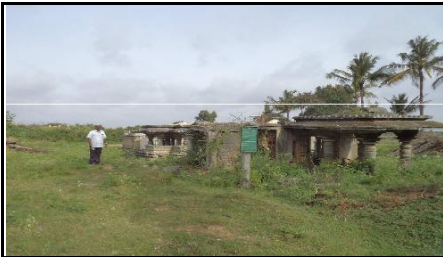
<p>39. Conservation of Govindeshwara temple at Koravangala, Hassan Taluk, Hassan District</p>

<p>The Govindeshwara temple structure was built on an Adhistana with small architectural members in schist stones and the Bhatti with the architectural carvings of Devakostas and Pilasters up to the roof level, and, top courses with Kanta, Hara and Kapota with missing parapet and disintegrated roofing. The interior of the temple consists Garbhagraha and Antarala with ornate door frames, door jambs and lintels beautifully carved with perforated windows, floral motifs and the pillared hall in the front with the most ornate carvings of lathe turned pillars with bases at the bottom and round cushion at the top and pillar capitals etc. The main temple ceiling in the center has large lotus petals and buds beautifully carved. The whole temple structure stands on a raised</p>

with little height found in the middle of thick vegetation and highly disturbed condition of parapet, terrace and missing members.

The disturbed flooring work remains half done with the original members. Pointing work was done with cement mortar to stone joints in thin line. Weather proof course was provided all over the roof with madras terrace roofing in lime concrete with WPC. Newly carved architectural/plain dressed members as per original were– Missing architectural stone members at one of the entrance replaced

<p>The overall conservation work carried out in accordance with the archaeological work codes, principles and guidelines was found satisfactory with the suggestion that scientific debris clearance around the monument, approach road, pathways and stone pavement provisions should have been provided in the estimate. In the absence of this, surroundings of the monument have thick vegetation and stagnation of water around the monument, causing a big threat to the monument. Protection may be provided by fencing around the monument as per archeological conservation norms.</p> <p>Conservation work executed is deviated by using number of new stones and found not satisfactory, as a number of original members either mutilated / defaced are stacked in a huge heap nearby should have been used by tracing their original place. The flooring work throughout the temple is incomplete.</p>
<p>40. Government Museum Madikeri</p>

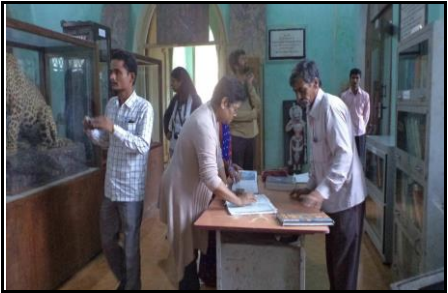
<p>Estimated Cost: 10.00 Lakhs</p> <p><b><u>GPS</u></b> 12°26'12".08N 75°45'30".32E</p>	<p>The development works carried out and the following observations are as under:</p> <p>Size stone masonry work seen and verified along with estimate found correct.</p> <p>Coping cement concrete above size stone masonry carried out as per estimate item provision.</p> <p>Burnt brick masonry work executed seen and satisfied.</p> <p>PVC (oripalst) pipes works executed seen and satisfied.</p> <p>Wire cut modular brick masonry for pedestals works seen and satisfied.</p> <p>Matti/Nandi wood frame for windows and ventilation work seen and satisfied.</p> <p>Inspection chamber with burnt brick work seen and satisfied.</p>

<p>Resetting of Mangalore tiles, fixing of Honne wood planks work carried out.</p> <p>Antifungal paint, emulsion painting to walls, synthetic enamel painting painted and applied as per estimate.</p> <p>Sal wood frames with teak wood planks (pedestals) and Sintex water tanks (1000 ltrs &amp; 500 ltrs capacity) provided work seen satisfied.</p> <p>Overall museum works were executed as per estimate provisions physically verified in terms of quality and quantity and found satisfactory estimate.</p>
<p>41. Government Museum Mysore</p>

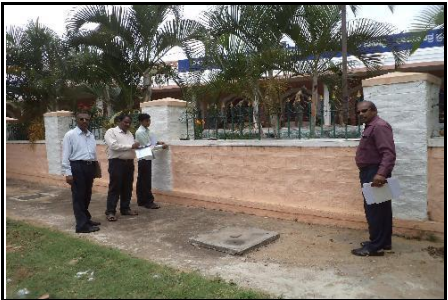
<p>Estimated Cost: 25.00 Lakhs</p> <p><b><u>GPS</u></b> 12°18'07".31N 76°39'30".94E</p>	<p>Civil works of compound wall was in accordance with the estimate provisions. Compound wall constructed around the office of Department of Archaeology, Museums and Heritage, Mysore the following observations are made :</p> <p>The compound wall constructed long back, the foundation part hidden underneath the ground level which cannot be seen and evaluation cannot be assessed. The only visible part above the ground level executed in stone masonry (Wall) with cement mortar by providing for 02 main entrances.</p> <p>Stone masonry pillars in between at regular intervals with cement concrete coping at the top and stone masonry basement at the bottom. Over the compound dwarf wall M.S rectangular grills frames fixed along with rectangular poles on the East, North and South while on the west provided barbed wire with M.S angles (rear side of the museum).</p> <p>Two designed M.S gates fixed as per estimate provisions. (One on the East and another on the South West corner).</p> <p>Along this compound wall concrete slab covering the drain executed as per the estimate provisions.</p>

<p>Within the compound around the main building, the gap in between area developed with beautiful landscaping by providing grass and plants.</p> <p>Garden lights with all necessary fittings etc as per estimate work executed. Sprinkler heads work executed.</p> <p>Under mentioned works not executed:</p> <ul style="list-style-type: none"> <li>i. Cascade (water fall) of 12’ height (Estimate item No-5 of Part B)</li> <li>ii. Construction of pond of fountain about 10ft radius(Estimate item No-6 of Part B)</li> </ul> <p>Overall museum works executed as per estimate provisions physically verified quality and quantity wise found satisfactory.</p>
<p>42. Conservation of Sri Chennakeshva temple at Bherya, K.R.Nagar Taluk Mysore Distirct.</p>

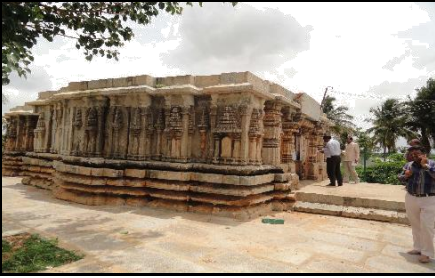
<p><b>History of the Monument:</b></p> <p>Bherya Village of Mysore District is at about 68 km from K.R. Nagar taluk place. Sree Channakeshava Temple is situated in the middle of the village Bilikrere Beur road</p>	<p>The monument/temple is situated in the middle of the village on a raised platform with open Pradakhashinapath around the temple, facing East built in schist stone architectural members of Hoysala style ,consists of Garbhagruha and Antarala with beautiful architectural carvings of door frames, Dwarapalas and Lotus buds motifs and ornate Lalatbimba etc with a front ornate pillared Mantap, having most ornate Lotus buds with intricate carvings of exquisite beauty in the ceiling center of Navaranga. The main entrance door frame has standing ‘Dwarapalas’, Lalatbimba missing and supported by two most ornate architectural pillars is more impressive. The temple is carved with architectural pillars, Devakostas around and on the Bhatti below, Adhistana carvings of a few ‘Ramayana stories’ are seen in the front. Above the Bhatti portion consisting Kanta, Hara, Kapota and Parapet is totally missing. The approach to the main temple seems to have been provided probably with the entrance porch, which can be assumed by the architectural ruins/remains scattered in the front.</p>

<p>passes through Behrya Village.</p> <p>Estimated Cost: 30.00 Lakhs</p> <p><b><u>GPS</u></b></p> <p>12°35'27".65N</p> <p>76°20'59".78E</p>	<p>While examining the monument each and every architectural members both exterior and interiors are found with the marks of red ochre color course by course clearly speaking the story of dismantling and resetting of archaeological monument conservation works, in accordance with the works code and principles.</p> <p>It is seen that the monument except Garbhagruha inner face, the entire temple was dismantled following the running numbers course by course up to the bottom. Regarding removal and relaying the foundation nothing is mentioned in the estimates. As per the estimate basement course was provided and restored temple Adhistana as per the original by following the alignment and the respective members as per the numbers by giving the side support of brick masonry in cement mortar.</p> <p>The Bhatti portion has been restored as per the original by core filling in between the walls with BBM and cement mortar up to the roof level. The most of the missing original members of Kanta, Hara, Kapota and Parapet are carved as per original style and replaced all around the temple. A few architectural/plain dressed members of Bhatti, Adhistana were replaced as per original. The interior of the temple was replaced by new beams and pillar capitals.</p> <p>The missing architectural member on the front main entrance was replaced with a heavy block of rectangular schist plain stone. Pillared hall restored with flooring followed by covering ceiling slabs as per original without harming/ defacing/ mutilating/ deviation of the orientation etc. WPC provided all over the temple. Stone pavement was provided all around the temple and steps with balustrades at the entrance. Pointing work in cement mortar in thin line both on exterior and interior executed.</p>

<p>Missing original members replaced with new members by carving /plain dressing as per original were: –Beam s supporting roof, – Pillar capitals,- Plain finished members (B hitti), Plain and architectural numbers replaced on Bhitti,- Chejja stones, Rectangular massive schist stone fixed on the front entrance.,- Parapet stone members plain dressed replaced as per original. The front plat form first basement course was reset with original stones, further top course provided with massive granite dressed stones. Granite rectangular massive stone steps provided to the staircase along with 2 Nos Balustrades. Stone pavement all around the temple provided, Cement pointing done to stone joints. WPC provided all over the temple at the top.</p> <p>The overall conservation work executed in accordance with the archeological work codes, principles and guidelines is satisfactory. However, the scratches of rubbing of architectural stone members on Adhistana and Bhitti should have been avoided by the contractor. Since this is unavoidable during the course of execution of works sometimes due to the negligence of workers/difficulty in assembling the massive members in minor rear cases cannot be viewed seriously.</p>

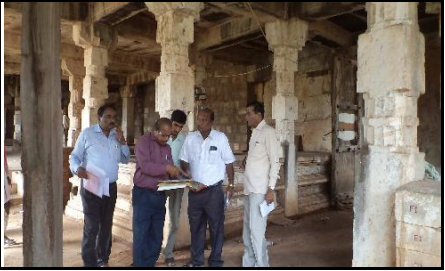
<p>43. Conservation of Sri Bhujngeswara temple at Umathur, Chamarajanagar District.</p>

<p>The monument/temple is situated within the tall prakara wall in the middle of the village, facing East built in granite stone architectural members of Chola style and consists of Garbhagruha and Antarala with architectural carvings of door frames and Lalatbimba etc with a front architectural pillared Mantap, with the carvings of ‘Pearl/Pendants’ ‘Mala ’ at the bottom and fluted with a band in the center and at the top floral motifs. Some of them with bell motifs with round cushion and square capital with lotus petals. There is a beautifully carved ‘Nandi’ in the Antarala, whereas the cult deity of Lord Shivalinganga called ‘Bhujangeshwara’ is in the Ga rbhagruha with Shikhara built in BBM with lime mortar and stucco</p>

<p><b>History of the Monument:</b></p> <p>Sree Bhujangeswara Temple at Ummattur Village is situated at about 30 km from Chamarajanagar.</p> <p>Estimated Cost: 41.00 Lakhs</p> <p><b><u>GPS</u></b></p> <p>12°35'27".84N 76°20'59".87E</p>	<p>moldings/figures highly disturbed and missing. The main entrance with a tall and large door frame with architectural carvings from top to bottom with Lalatbimba is more impressive. while in the interior there are two raised platforms with architectural pillars on both sides of the entrance namely 'UTSAVA MANTAPA' &amp; 'SABHA MANTAPA', akin to this a pillared cloistered Mantapa running on South and South west of the main temple. The approach to the main entrance begins with the visit to the tall monolithic lofty granite architectural 'DEEPASTAMBA' with the most attractive carvings of female dancing figures above the rectangular portion of the bottom. In the middle the fluted carvings with a round cushion at the top above which an inverted lotus petals with square shape at the top probably for placing Oil lamps for illuminating the surrounding and temple as well.</p> <p>Within the prakara on the North western side small Devi shrine is located with small Garbhagruha, Antarala and pillared Mantapa and a tall Shikhara facing East built with BBM in lime mortar. There are other sub shrines built in granite stones with architectural carvings in the interior with cult deities.</p> <p>The entire temple complex was found in highly deteriorated condition with collapsed walls/out of plumb accumulation of earth deposit with wild vegetation grown giving shelter to poisonous insects. The terraces were broken and dead, leaking heavily (known from the interior ceilings etc). It is also noticed that some stone masonry walls are constructed inside the temple. The ceiling and flooring members are missing and plinth sunken heavily.</p> <p>While examining the conservation works executed, it is noticed that numbering of each and every stone member of the temples and shrines inside the complex, in red ochre color was done indicating that procedure of archaeological conservation of</p>

The existing original Vimanais in highly disturbed condition with some portions missing and required modular's service is unfinished. Thus, the conservation work is required to all the sub shrines – Yaga Mantap, Sangeeta Mantap, Valli Shrid evi Subramaneshwar temple and Paravati temple were dismantled and restored as per original on the same lines of main temple by replacing with new architectural members in place of missing originals WPC with lime concrete was provided all over sub

The weak sunken foundation was removed and strengthened by laying cement concrete bed with U.C.R stone masonry and cement concrete coping.

The Bhatti portion was restored as per original by core filling in between the two faces of walls (veneerings) with BBM and cement mortar up to the roof level. Most of the missing original members of Bhatti, Kanta, Hara, Kapota and Parapet were replaced by newly carved architectural members in place of originals, on the Northern side mainly and other places. The ceiling and flooring members and pillars also were carved and replaced in place of missing originals as per original style of architecture. WPC with lime concrete was provided on terrace and all over the temple. Pointing work in cement mortar in thin lines both on exterior and interior was also executed.

Missing original members replaced with new members by carving /plain dressing as per original.
